Concrete and Fire: The crash of El Al flight 1862

[Admiral Cloudberg](#)

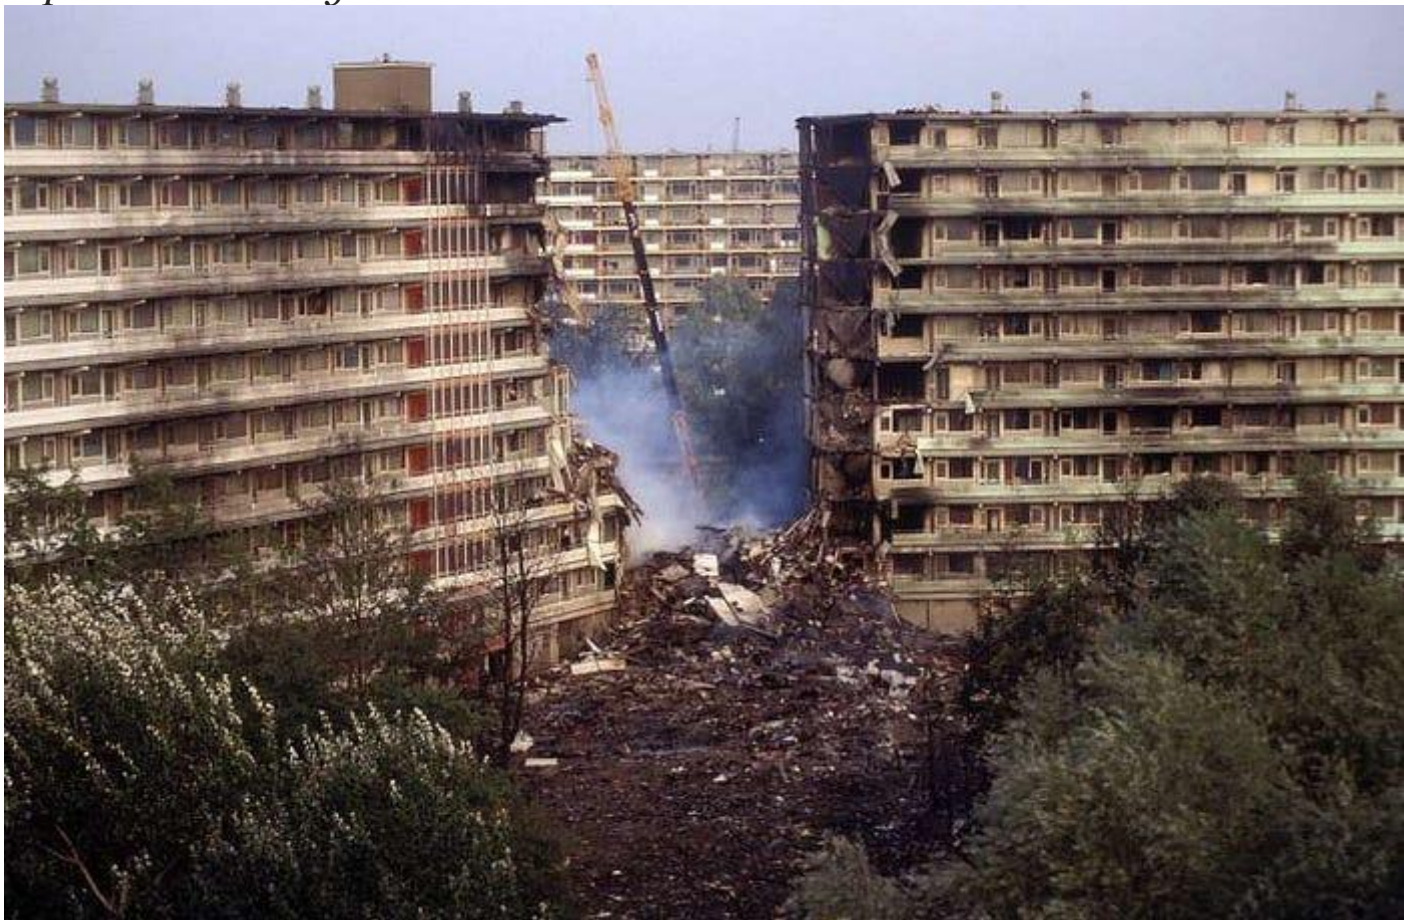
The crash left a high rise apartment building in ruins. (Pool Merillon/Ribeiro via Getty Images)

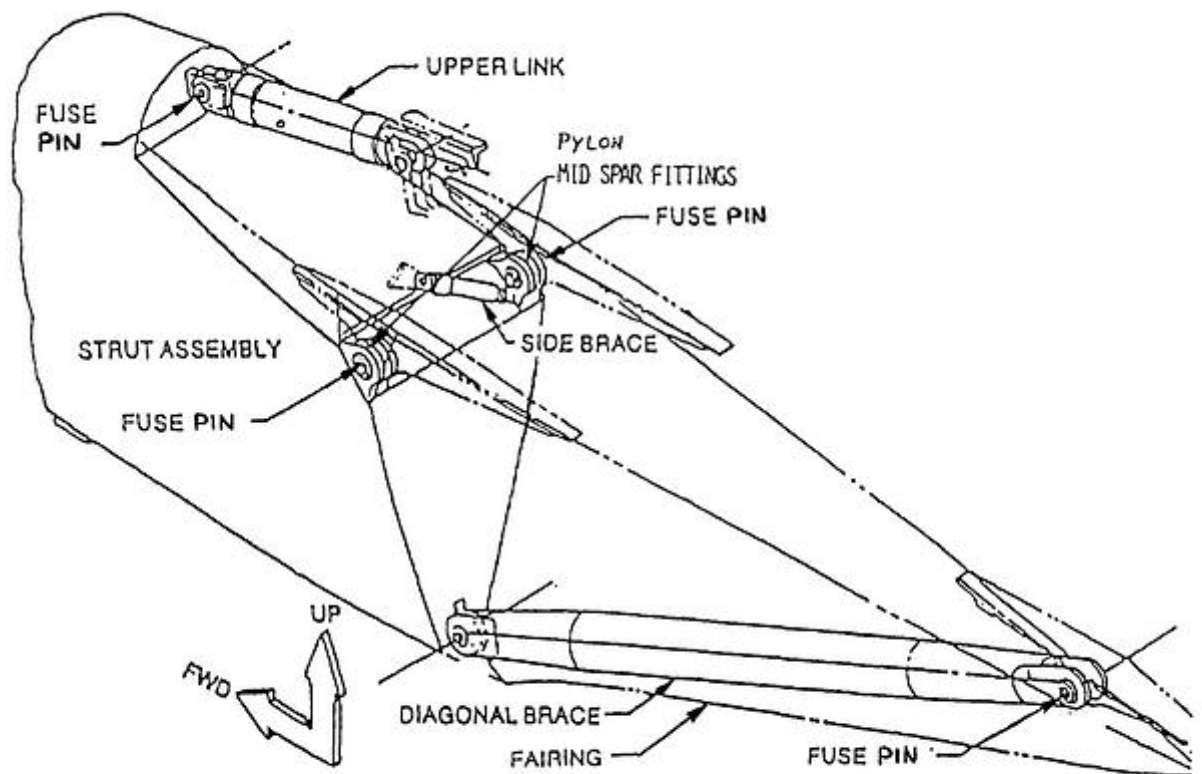
A diagram of the 747 engine pylon attachment points. (Netherlands Aviation Safety Board)

The Boeing 747 engine pylon is attached to the wing by four fittings: one at the front, one in the back, and two in the middle (or midspar). Each of these fittings consists of a wing-mounted male lug and a pylon-mounted female lug, which are connected by a fuse pin. The four fuse pins are the weakest part of the pylon, but this is by design. Every airplane system and structure contains planned failure sequences which work to minimize damage in the event of an overload. In the case of the 747's engine pylons, the fuse pins were designed to fail at a lower load threshold than the fittings themselves, ensuring that if the engine is torn off the wing — perhaps due to extreme turbulence, or a gear-up landing — the fuse pins will fail first, causing the engine to separate cleanly without ripping open the fuel tanks located directly above it. In theory, this should allow an engine to break off upon reaching its design load limit without starting a fire or otherwise compromising the plane's ability to fly.

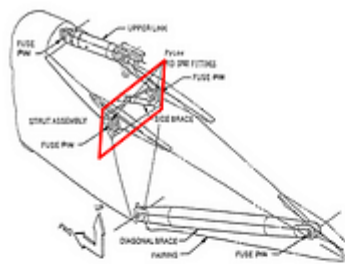
Diagram of the midspar attachments and their failure sequence. Both fuse pins pictured here were suffering from metal fatigue: the inboard midspar pin on its inboard shear face, and the outboard pin on its outboard shear face. The inboard pin would ultimately fail first.

Under normal flight loads, the cracked inboard midspar fuse pin on the number three engine pylon broke on its inboard shear face. That meant the loads on the engine pylon were transferred only through the outboard lug of this wing fitting, instead of both lugs. Under the extra stress, the outboard lug of the inboard midspar fitting broke, and the failure cascaded from there, as the outboard midspar fuse

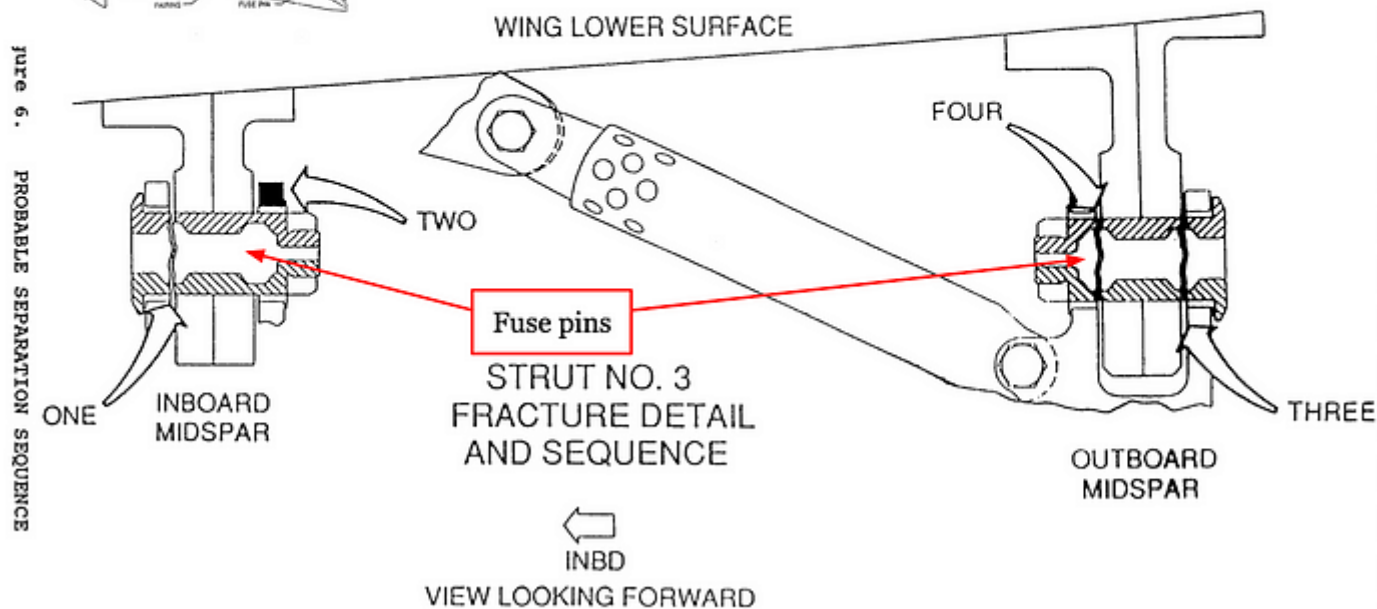
Close-up of the midspar attachments and their failure sequence. (Netherlands Aviation Safety Board)

Although they could not assess the extent of the fatigue damage on the fuse pin which started it all, investigators did find similar damage on the outboard midspar fuse pin, which was recovered. This fuse pin had a fatigue crack four millimeters deep which stretched 50% of the way around its inner bore, apparently originating at several separate points along an abnormal machining groove. When the inboard fuse pin broke and loads were transferred to the outboard pin, this pin failed along the pre-existing crack.

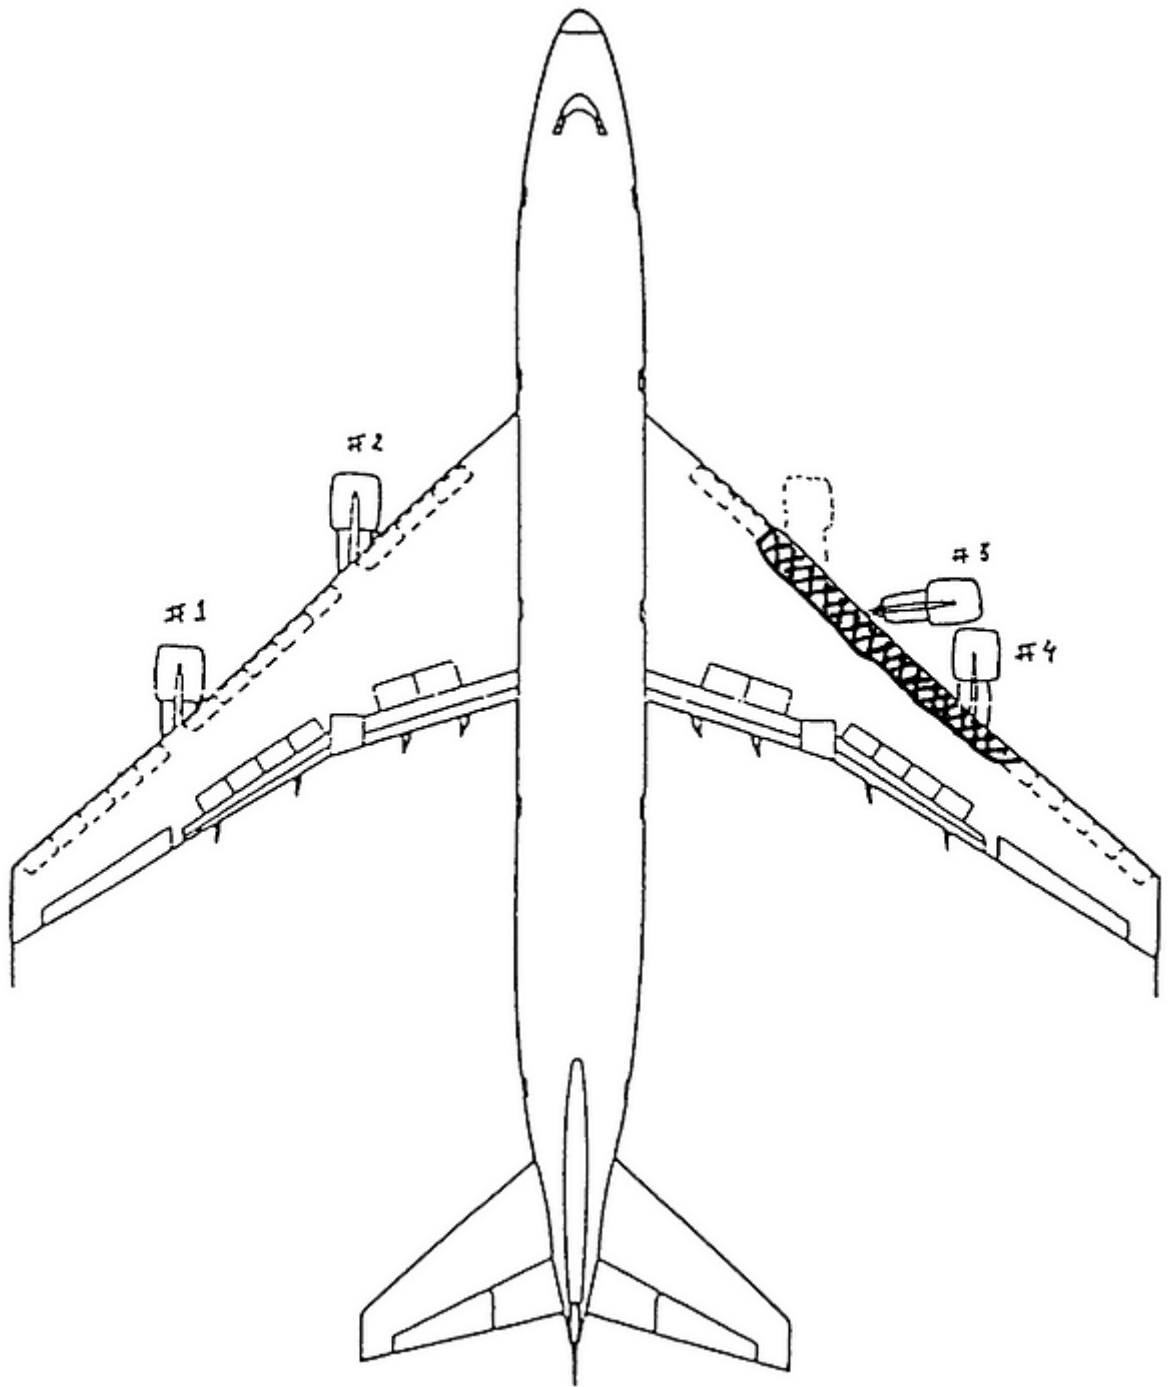
Overview of the damage suffered by the plane. The missing area the of the leading edge is crosshatched. (Netherlands Aviation Safety Board)

As the pilots began extending the flaps in order to slow down for the approach, it would have become apparent that something was wrong with the leading edge Krüger flaps on the right wing. The problem was that these flaps were entirely gone, but it’s not clear how this manifested to the crew, and they certainly did not know the true extent of the damage.

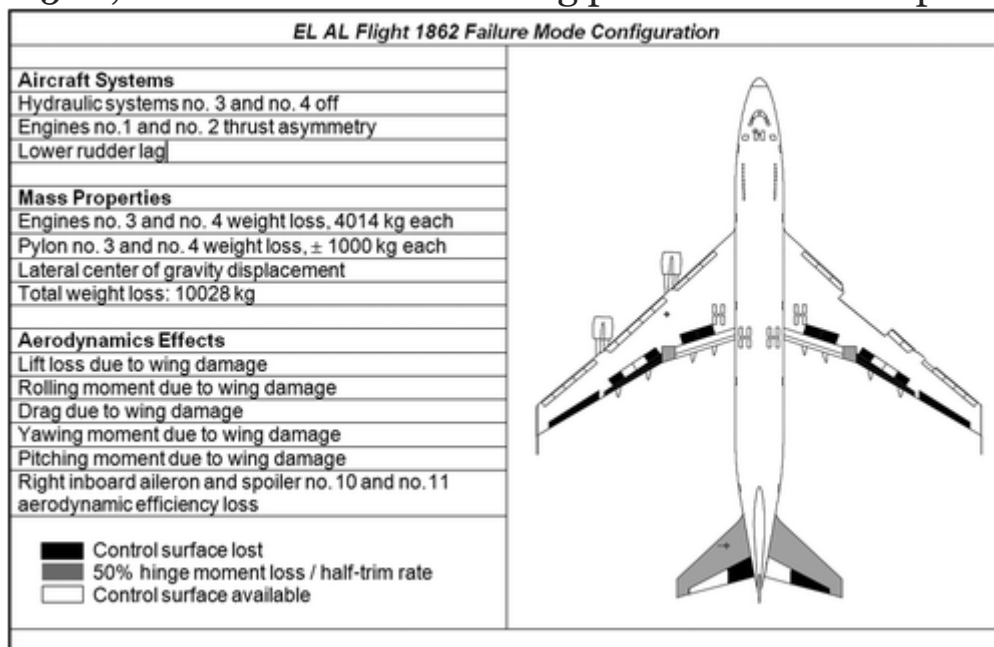
Due to the failure of the hydraulic systems, control was difficult due to degradation of some of the flight controls, in particular the outboard ailerons. (M. H. Smaili et al)

Fuchs was losing control of his plane due to two converging principles of aerodynamics. First of all, the asymmetric thrust produced by the engines, as well as the damage to the right wing, gave the plane a strong inherent desire to roll to the right, a problem which became worse as flight 1862 slowed down for landing. At lower speeds, a plane must fly at a higher angle of attack — the angle of the wings relative to the airflow — in order to maintain lift. But at higher angles of attack, the difference in lifting capability between the intact left wing and the damaged right wing increased, further exacerbating the roll. At the same time, the effectiveness of an airplane's flight controls decreases proportionally with its speed, meaning that as the plane decelerated and the roll moment increased, Captain Fuchs' ability to counteract it with the controls became progressively more limited. His authority was constrained even further by the fact that the outboard ailerons had lost hydraulic power.

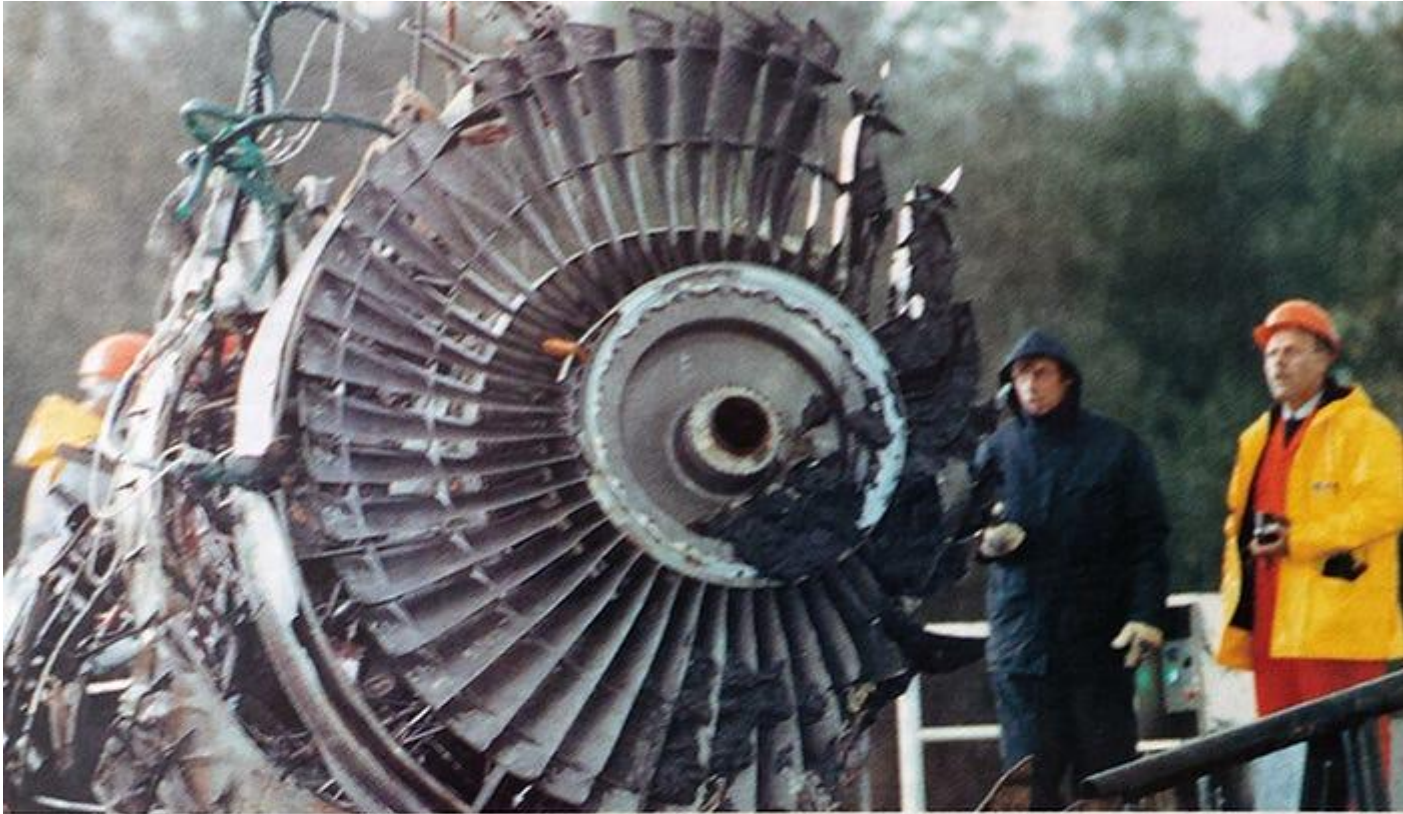
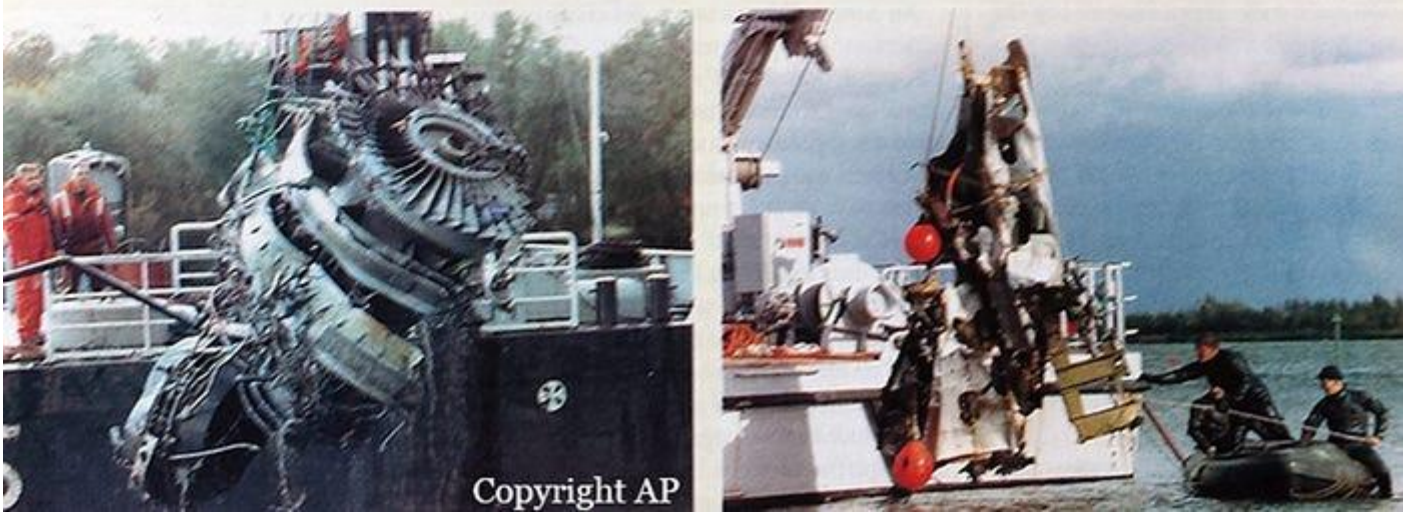
The missing engines are recovered from the Gooimeer. (AP)

In the case of flight 1862, the number three engine pylon's inboard midspar fitting and its associated fuse pin were never found, having been lost in the mud beneath Lake Gooimeer. However, damage to the other fittings could only be explained if the inboard midspar fuse pin had failed first.
