# Aerodynamic, Flight Mechanical and Flight Technical Aspects of the EL AL 1862 Accident Investigation

H. Tigchelaar,  
RLD

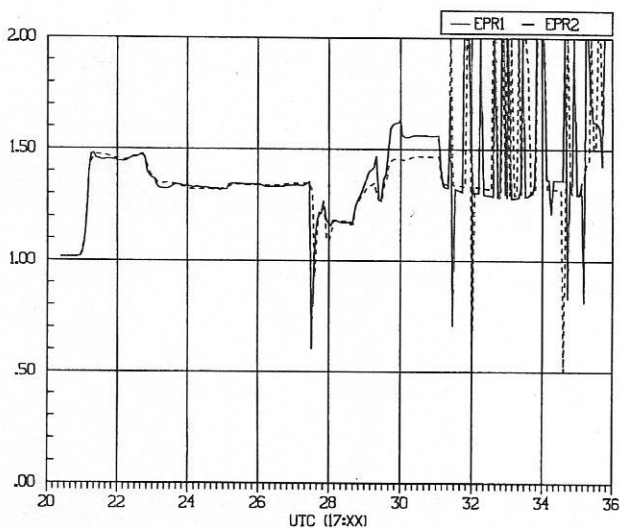
Fig. 1 Unfiltered EPR data from DFDR

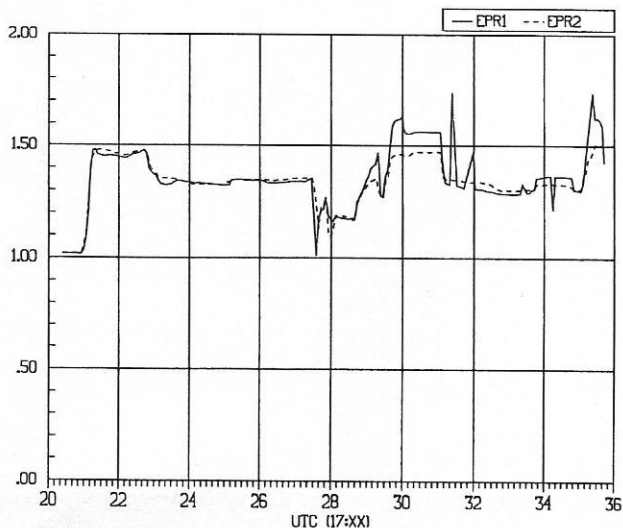
Fig. 2 Filtered EPR data from DFDR

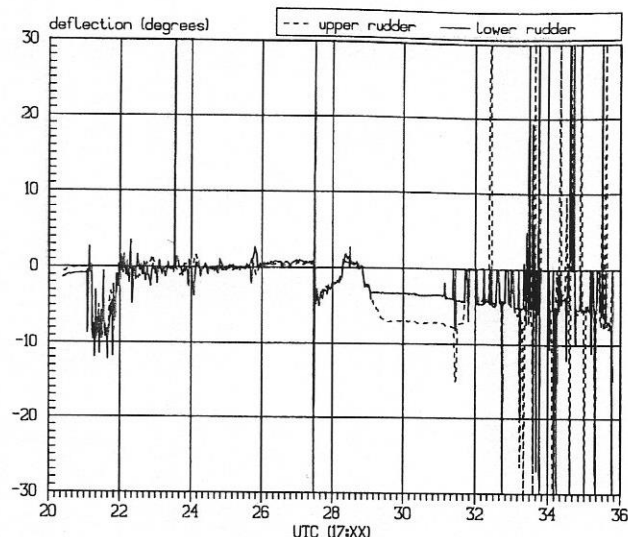
Fig. 3 Unfiltered rudder deflection data from DFDR

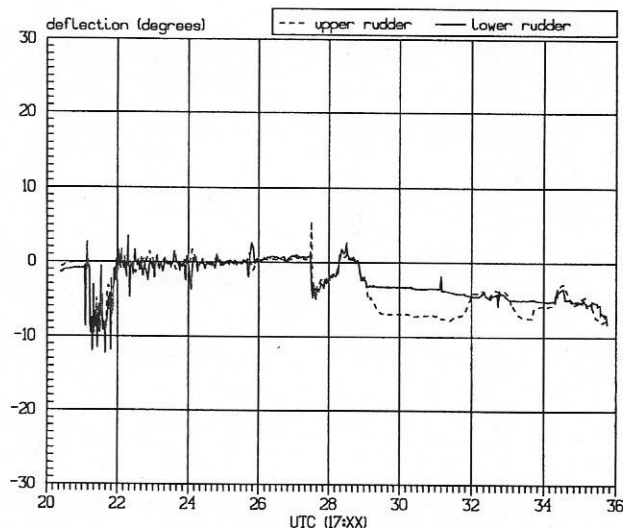
Fig. 4 Filtered rudder deflection data from DFDR

From the DFDR it can be observed, that about 2 minutes after engine separation the lower rudder is restricted in its maximum deflection although not quite at a constant angle. Despite intensive efforts by the investigation team and Boeing it was not possible to find an acceptable explanation. However it most certainly contributed to the degradation of directional control. This unexplainable rudder split can be seen in Fig. 4 and 8.

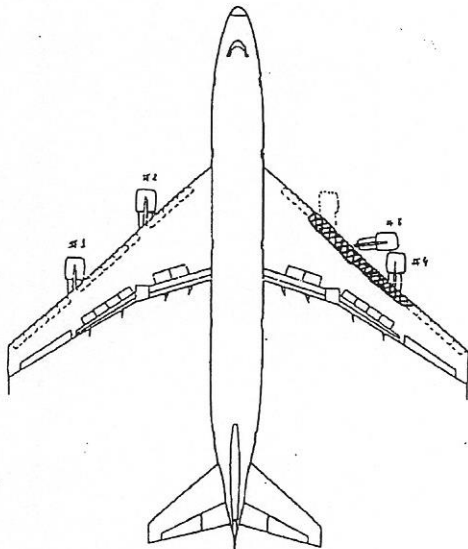
Due to the separation of both engines and pylons on the right wing corresponding systems were lost. Therefore hydraulic systems 3 and 4 were inoperative. This in turn resulted in a significant reduction of the availability of the hydraulically driven primary and secondary flight controls.

Fig. 6 Estimated damage to the aircraft

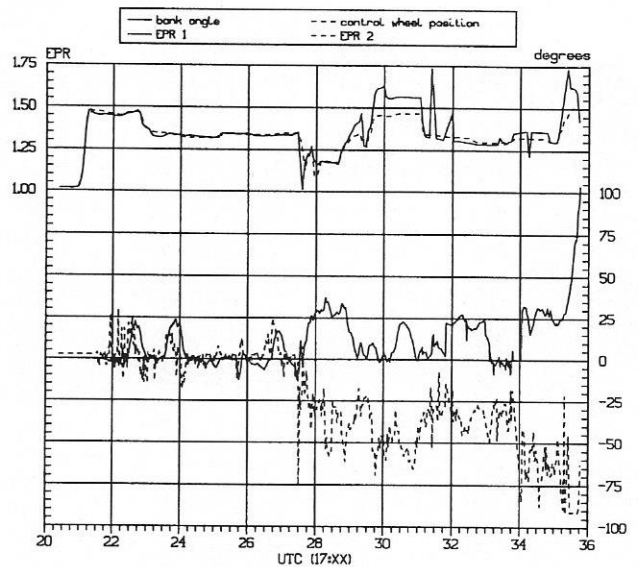
marginally controllable. The position of the flight controls (60 % left wing down aileron wheel deflection and full rudder pedal position) was rather unusual. Standard Boeing flight techniques in engine inoperative flight are rudder pedal application until the aileron wheel is neutral with Maximum Continuous Thrust (MCT). Even with Go-around thrust such a large aileron wheel deflection would be unusual. The data from the DFDR are given in the following two figures.

Fig. 7 Bank angle, aileron wheel position and EPR

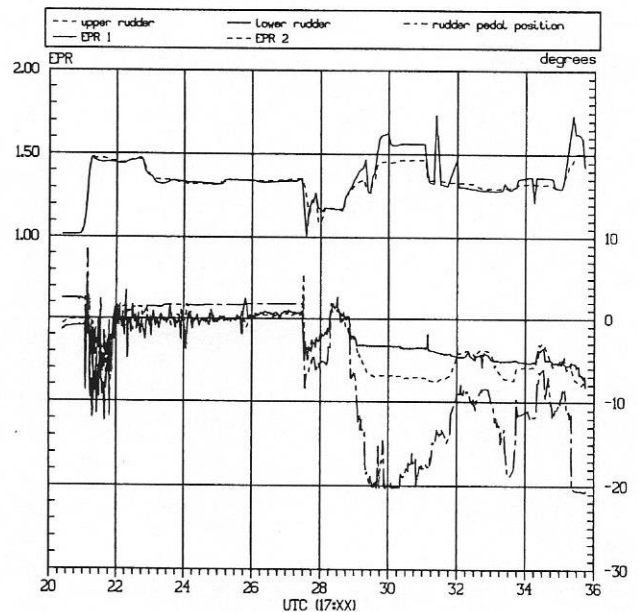
Fig. 8 Rudder deflection, rudder pedal position and EPR

direction of the "dead" engine. The thrust application and delayed rudder application can be seen in Fig 8.

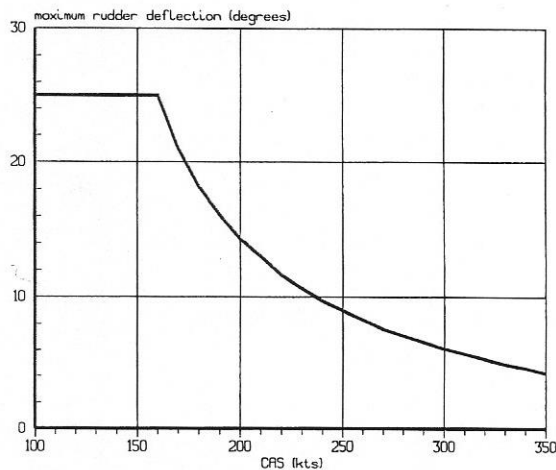
Fig. 9 Rudder deflection as a function of airspeed

This gearing is chosen to protect the vertical fin against excessive airloads due to full rudder pedal input at high speed. This keeps the maximum side load on the tail constant as airspeed increases. It will not be surprising that there is an inverse quadratic relationship between speed and rudder deflection.

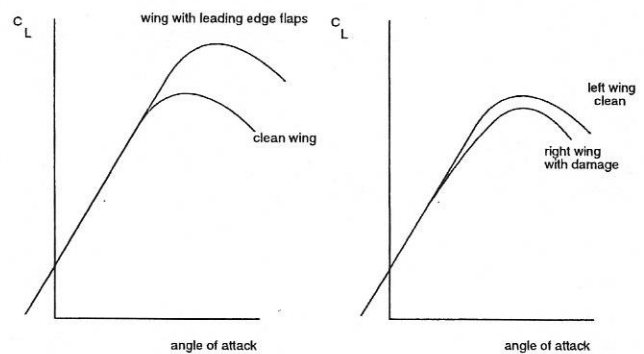
Fig. 10 Lift curve for various wing configurations

The right figure shows, that with increasing angle of attack there is a gradual degradation in lift on the damaged wing as compared to the clean wing. This results in a rolling moment in the direction of the damaged wing, that gradually increase as the angle of attack increases or if the speed decreases. In addition if a turn in the direction of the damaged wing is initiated at constant airspeed, the rolling moment will further increase due to the increase in load factor and corresponding increase in angle of attack. This hypothesis could be verified from DFDR data.
