Aerodynamic, Flight Mechanical and Flight Technical Aspects of the EL AL 1862 Accident Investigation

**H. Tigchelaar,
RLD**

On October 4, 1992 an El Al Boeing 747-258F crashed into an apartment block in the Bijlmermeer, Amsterdam. The findings of the accident investigation were published in Aircraft Accident Report 92-11 by the Netherlands Aviation Safety Board. This paper summarizes a presentation given for the Netherlands Association of Aeronautical Engineers early 1995. In that presentation a number of findings and recommendations of the accident investigation were amplified from an aerodynamic, flight technical and flight mechanical point of view. It should be realised, that the whole accident investigation did comprise many more aspects, that are not covered in this paper.

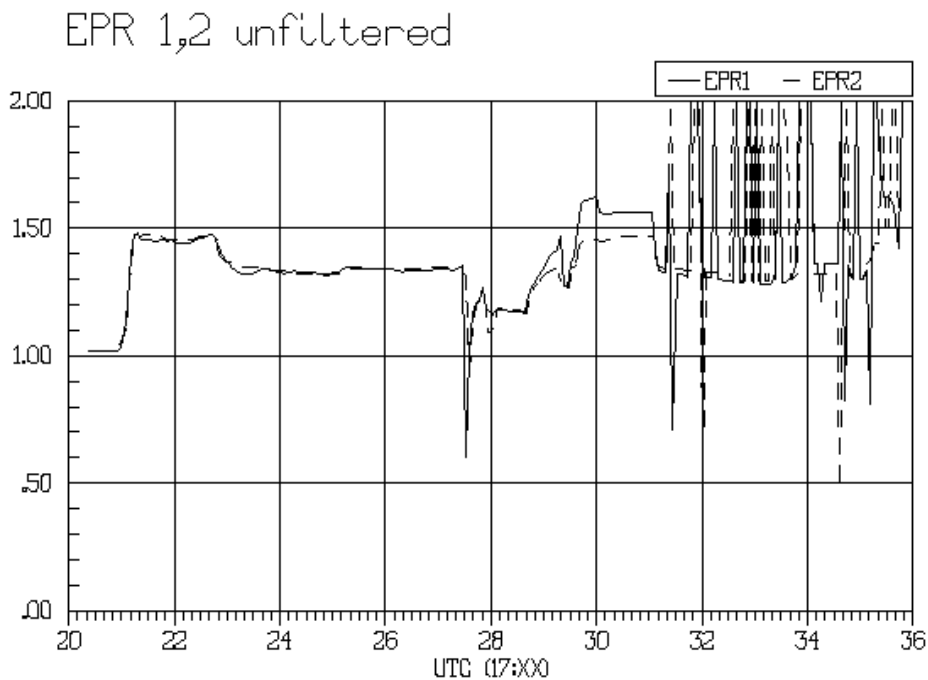
Fig. 1 Unfiltered EPR data from DFDR

These figures clearly show the importance of this manual data reduction process in order to obtain understandable data. The importance of these data for the investigation will be discussed in a later chapter. As the data corruption was mainly caused by the fire damage to the DFDR tape and much time had to be spent on data reconstruction, one of the recommendations of the official aircraft accident report was:

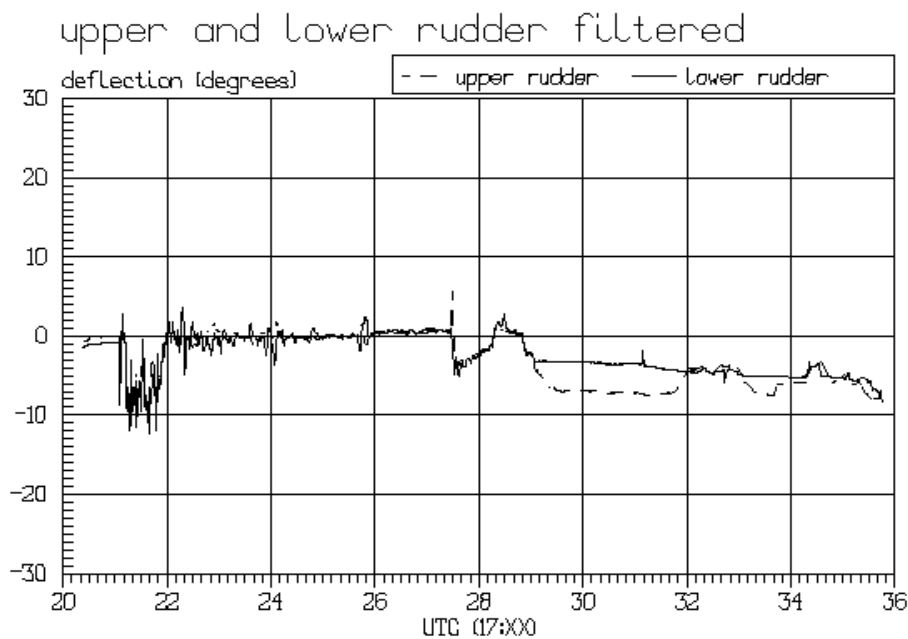
Fig. 4 Filtered rudder deflection data from DFDR

From the DFDR it can be observed, that about 2 minutes after engine separation the lower rudder is restricted in its maximum deflection although not quite at a constant angle. Despite intensive efforts by the investigation team and Boeing it was not possible to find an acceptable explanation. However it most certainly contributed to the degradation of directional control. This unexplainable rudder split can be seen in Fig. 4 and 8.

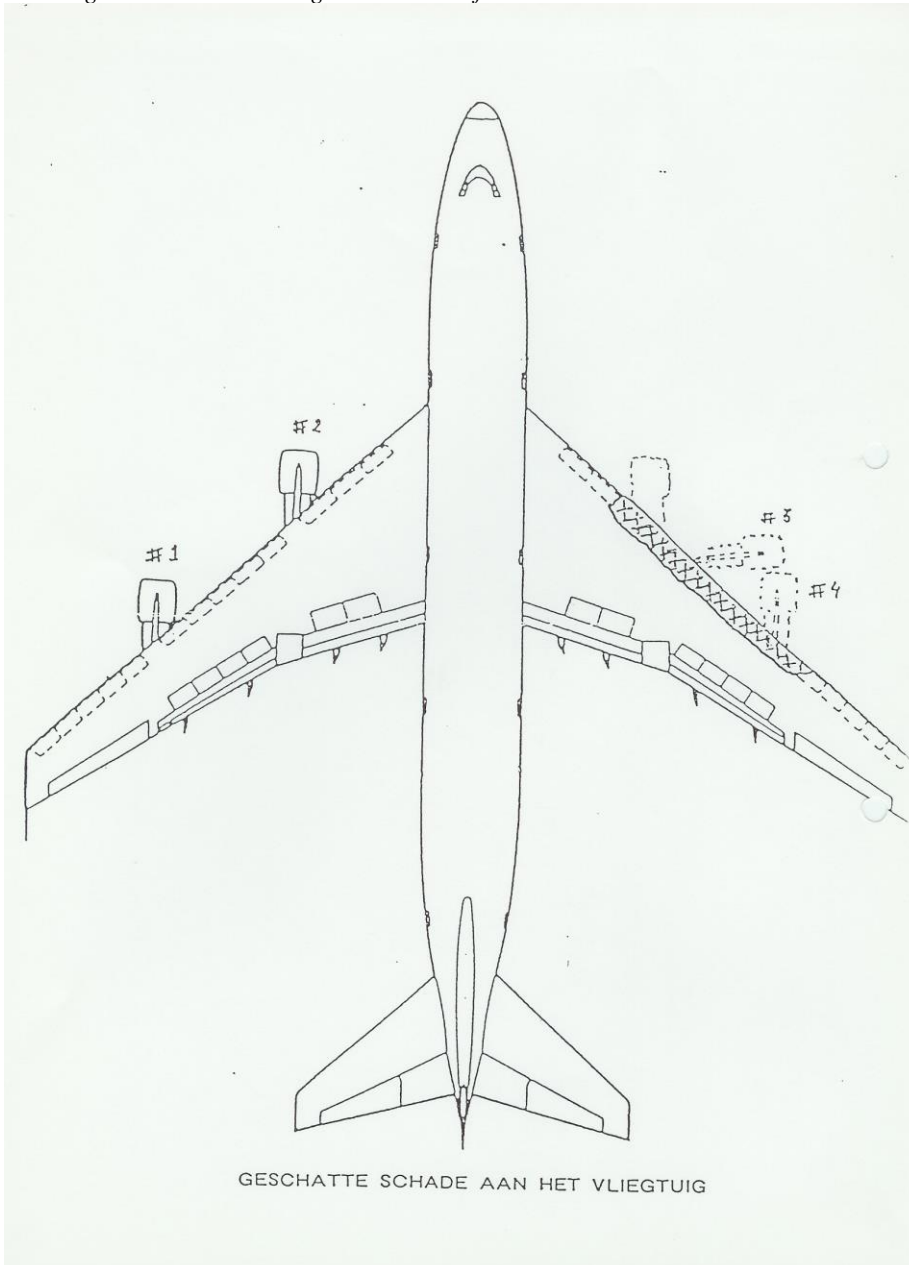
Fig 6 Estimated damage to the aircraft

Due to the separation of both engines and pylons on the right wing corresponding systems were lost. Therefore hydraulic systems 3 and 4 were inoperative. This in turn resulted in a significant reduction of the availability of the hydraulically driven primary and secondary flight controls.

Outboard trailing edge flaps have primary hydraulic control by system no 4, so hydraulic control of this system was lost. Inboard trailing edge flaps are driven by hydraulic system no 1 and therefore remained available. The trailing edge flap system also has alternate electrical control.

Roll control is by spoilers and in- and outboard ailerons. 66% of the spoilers were lost. All ailerons are driven by double actuators powered by two separate hydraulic systems. For all ailerons one hydraulic source remained available. However, the outboard ailerons are intended for low-speed flight only and are consequently locked out or deactivated, when the outboard trailing edge flaps are retracted.

The estimated damage to the wing based on wreckage information is given in the following figure.

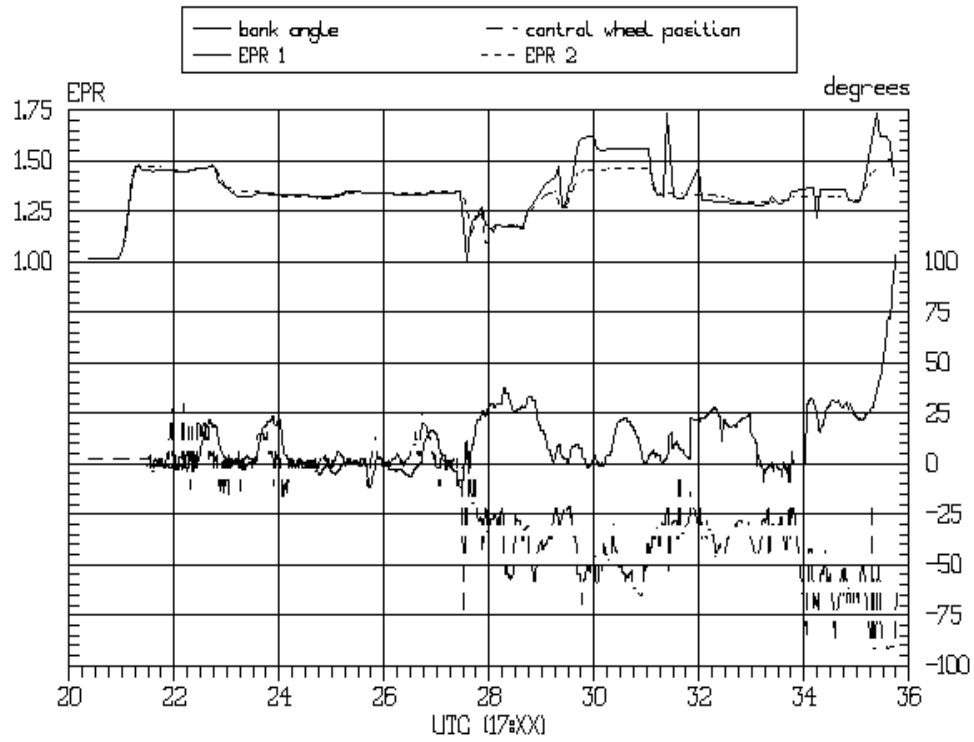
Fig. 7 Bank angle, aileron wheel position and EPR

From the DFDR the following situation emerged directly after engine separation. At a speed of 270 kts and Go-around thrust the aircraft appeared to be marginally controllable. The position of the flight controls (60 % left wing down aileron wheel deflection and full rudder pedal position) was rather unusual. Standard Boeing flight techniques in engine inoperative flight are rudder pedal application until the aileron wheel is neutral with Maximum Continuous Thrust (MCT). Even with Go-around thrust such a large aileron wheel deflection would be unusual. The data from the DFDR are given in the following two figures.

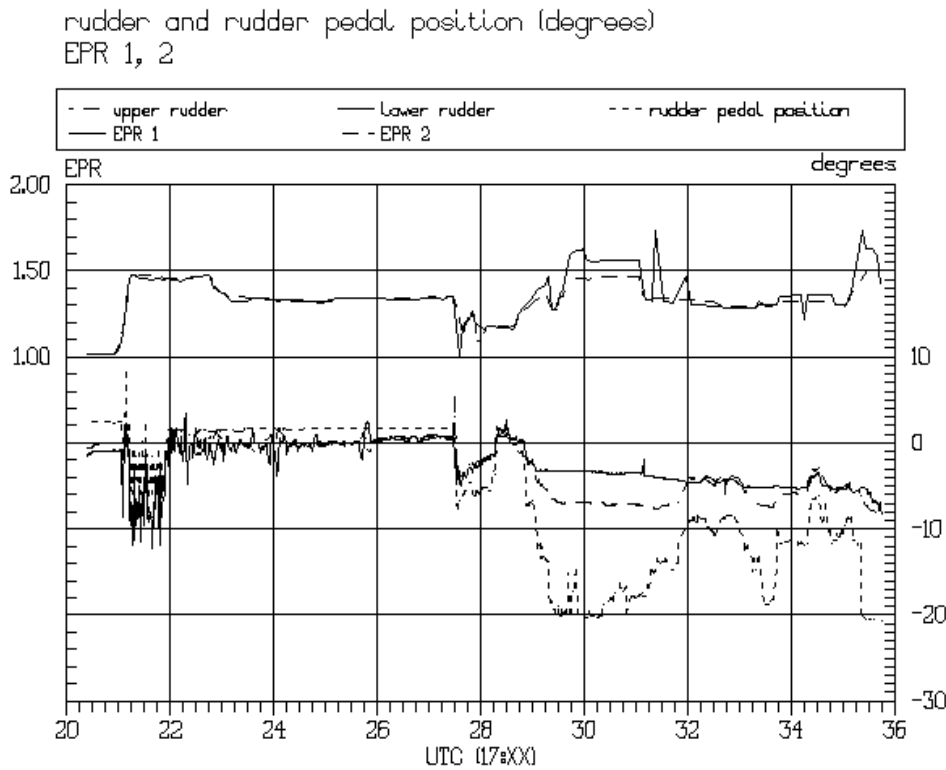
Fig. 8 Rudder deflection, rudder pedal position and EPR

The thrust application and delayed rudder application can be seen in Fig 8.

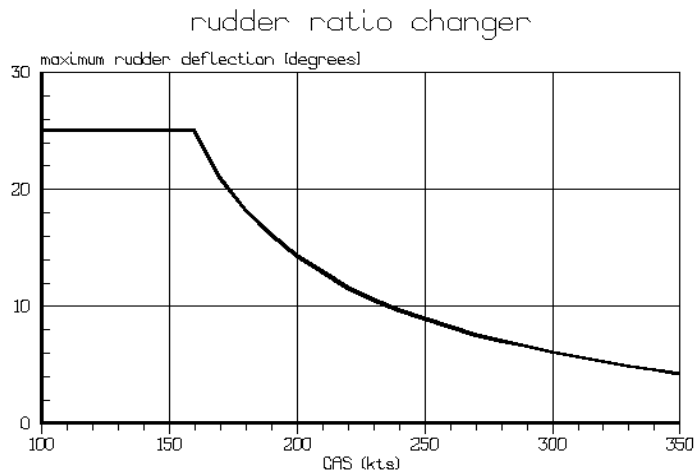
Fig 9 Rudder deflection as a function of airspeed

As explained earlier the rudder ratio changer modifies the gearing between rudder pedals and rudder surface. This also means, that the maximum rudder deflection is reduced with increasing airspeed. This is illustrated in the following figure, where an inverse quadratic relationship can be seen between airspeed and rudder deflection at full rudder pedal input.

This gearing is chosen to protect the vertical fin against excessive airloads due to full rudder pedal input at high speed. This keeps the maximum side load on the tail constant as airspeed increases. It will not be surprising that there is an inverse quadratic relationship between speed and rudder deflection. Another effect of relevance and well known to pilots flying Boeing aircraft is that, with constant thrust and varying airspeed at a fixed rudder pedal position, the aileron wheel position will be constant as well during engine-out flight. This is very convenient for the pilot performing an engine-out initial climb-out and acceleration after take-off. It also means that the lateral control margins remain constant with speed, which is in contrast to the intuitive assumption, that controllability margins will increase with increasing airspeed. The above can be verified by analysing the lateral-directional equations of motion. The analysis is outside the scope of this paper.

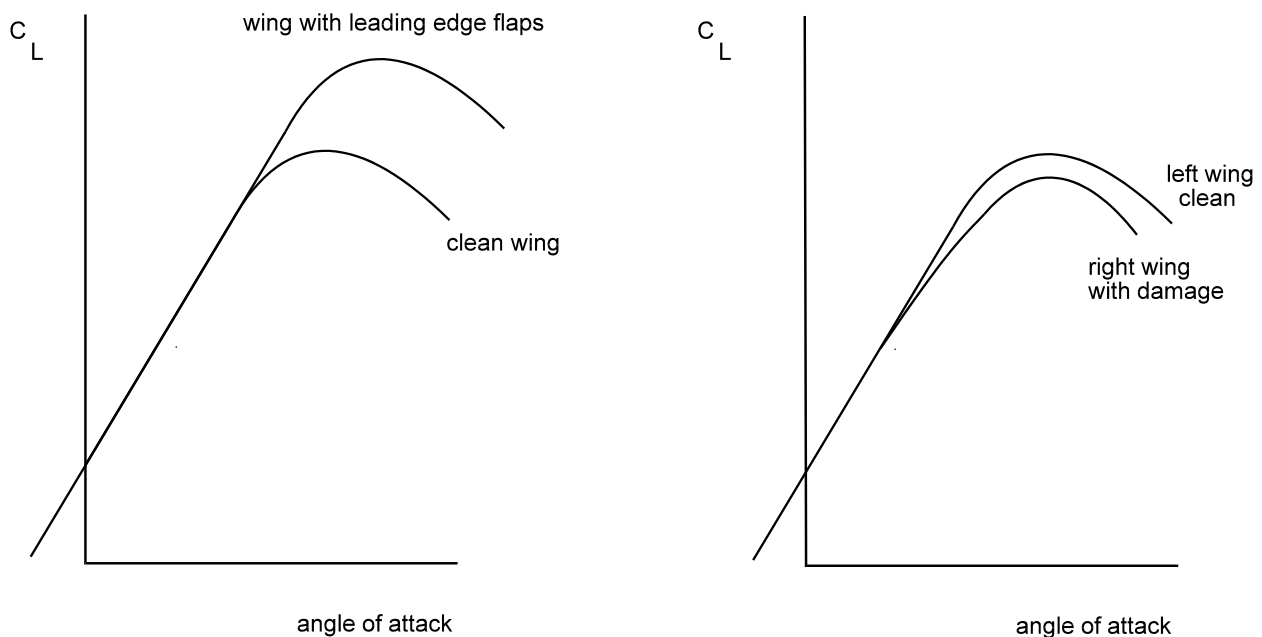
Fig 10 Lift curve for various wing configurations

The extensive damage to the leading edge of the right wing caused a significant asymmetric roll effect. Initially it was thought, that the final roll to the right was caused by the well known effects of leading edge flap asymmetry. This was checked in a simulator, but the effects of a total leading edge flap asymmetry would have caused a much more abrupt rolling moment, than was observed on the DFDR. Also it is well known from simple aerodynamic theory, that this rolling moment will suddenly occur, when a certain angle of attack is exceeded. This effect is illustrated in the following figure, where on the left side the classical lift curve is shown for a wing with leading edge flaps extended and retracted (clean wing). On the right side the estimated effect of the wing damage due to engine/pylon separation is shown:

The right figure shows, that with increasing angle of attack there is a gradual degradation in lift on the damaged wing as compared to the clean wing. This results in a rolling moment in the direction of the damaged wing, that gradually increases as the angle of attack increases or if the speed decreases. In addition if a turn in the direction of the damaged wing is initiated at constant airspeed, the rolling moment will further increase due to the increase in load factor and corresponding increase in angle of attack. This hypothesis could be verified from DFDR data.

It should also be noted, that the loss of the engine pylons has a significant effect on the lift of that wing.
