El Al Boeing 747-200 Amsterdam Crash

By: Rachel Gamblin Tiffany Vo

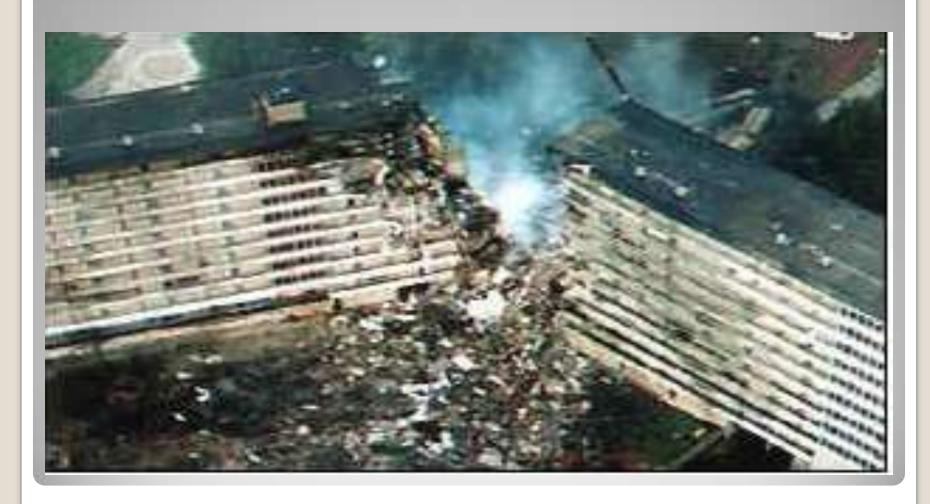
Apartment Complex

- Took off from Amsterdam
- Reached 4000 ft.
- Warning light for No. 3 engine had came on
- No. 4 engine was out
- Captain reported a control problem
- Captain radioed: "going down, 8162 going down."
- Crashed into apartment building

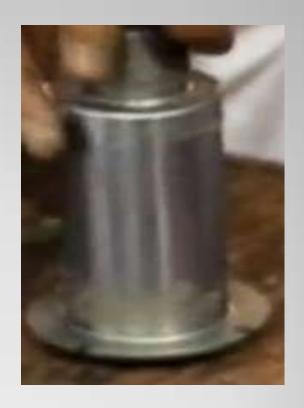
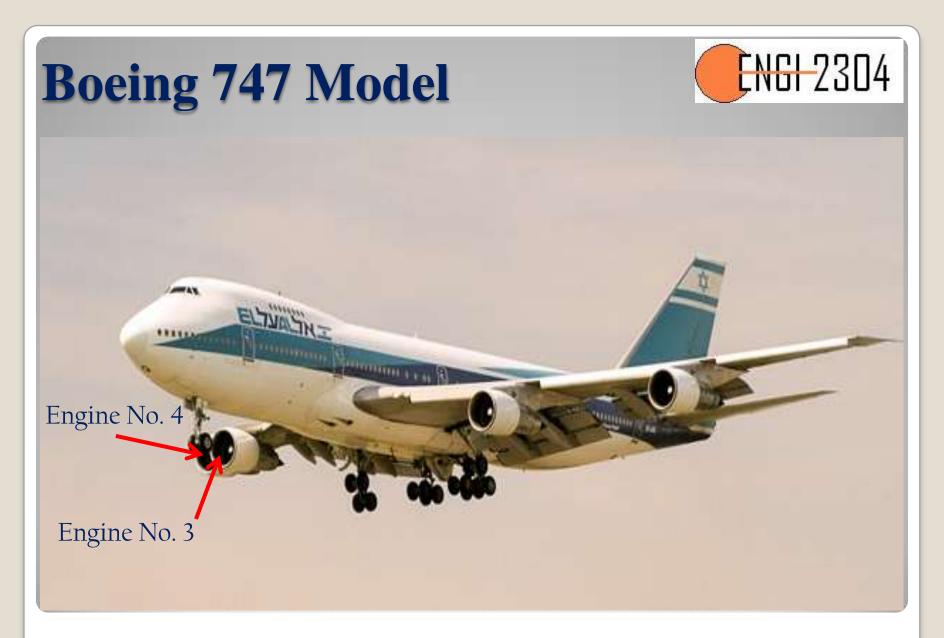
Fuse Pin

- Hollow cylinder shape
- Cadmium-plated steel,
- 5.5" long & 2.25" diameter
- Sturdy but fragile enough to break
- Develop corrosions and cracks

- Fuse pins failed on right inboard (No. 3 engine)
- Right outboard (No. 4 engine) was knocked out
- Encountered problems with flaps
- Lost control and slammed into ten-story apartment complex

- FAA & Boeing called for re-inspection of over 900 jets
- FAA required more frequent inspection of "old-style" pins
- In the first three hundred planes, found 499 corroded pins and 14 cracked pins (giving a defect rate of one out of five)
- Boeing continued attempts to design a corrosion-proof fuse pin
- Increase in design tendencies away from fuse pin attachment
